# Manhole Inspection Summary

Manhole # S07YY\_006MH

Insp Date: **7/16/09 10:04 AM**

**Location** Address: **3405 COPLEY ROAD**

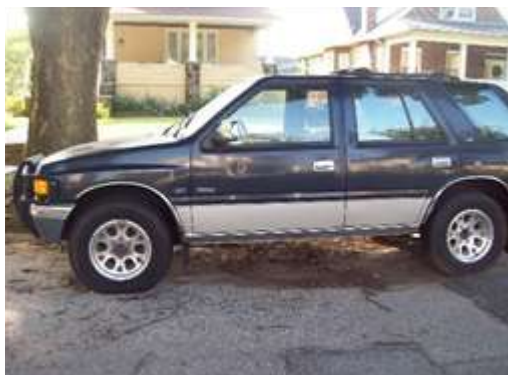
Location View

**Cannot Access - Car Parked On**

Comments **CAR PARKED OVER MH SEE LOCATION VIEW**
